Impact Testing on Reinforced Carbon-Carbon Flat Panels With BX-265 and PDL-1034 External Tank Foam for the Space Shuttle Return to Flight Program

*Matthew E. Melis, Duane M. Revilock, and Michael J. Pereira
Glenn Research Center, Cleveland, Ohio*

*Karen H. Lyle
Langley Research Center, Hampton, Virginia*

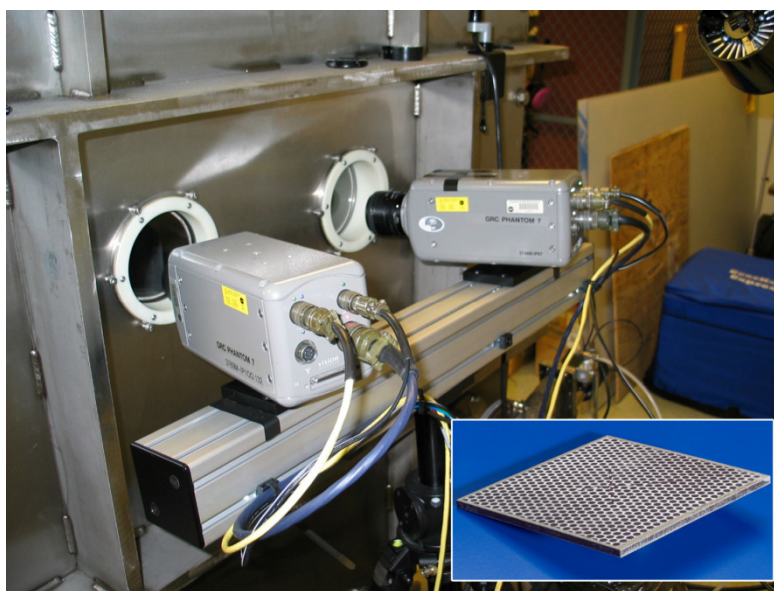
Figure 5.—ARAMIS Three-Dimensional Deformation/Strain Measurement System shown with static camera assembly setup at large vacuum gun viewing ports. Inset in lower right corner depicts paint pattern on back of the reinforced carbon-carbon panel.

The system works off image pairs taken simultaneously with two Phantom 7 cameras set up on a fixed beam, which viewed the back of the RCC panels undergoing impact. The image pairs were typically taken at 37.17 increments (~27 000 frames/s) with the exception of those taken in appendix D, which were 69.44 increments (~14 400 frames/s). The camera pair was set up outside the large vacuum chamber for the 90° impact tests and inside the chamber for the 45° tests. Inside mounting was necessary for the 45° tests to optimize the view of the panel backs. The outside mount configuration is shown in figure 5.

In order for the ARAMIS system to make its measurements, a painted speckle or spot pattern must be applied to the field area of interest. The backside of each panel was painted before the impact testing was performed. Testing was performed on small samples of RCC that were painted for use with the ARAMIS system. A scanning electron microscope was used to confirm that the paint did not excessively wick into the RCC panels and potentially change the RCC material performance and NDE techniques or flash thermography, and ultrasound tests revealed no adverse interference or artifacts due to the speckled paint pattern on the backside of the panels. The speckled pattern can be seen on the post-impact photographs in the appendices of this report. As the test program proceeded, an optimum paint pattern was adapted going from a “spatter” pattern to a pattern spray painted through a uniform stencil. This accounts for the two types of patterns seen in the photographs. The paint patterns were created by applying paint to the back of each test panel in two layers. The first layer is white paint that has a high reflectivity rating followed by black spray paint applied in a random speckle pattern or through the stencil. The inset in the lower right-hand corner of figure 5 shows the uniform paint pattern on the back of an RCC panel.

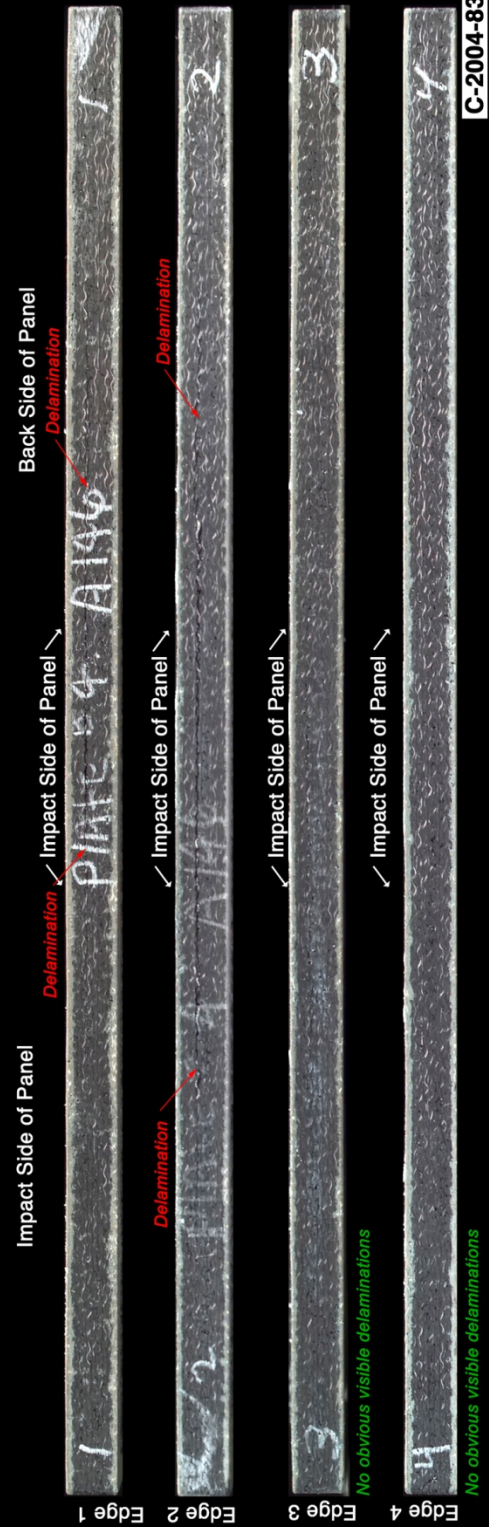
Panel A146-4 Post Test Images - 90 Degree BX265 at 1741 Feet Per Second

Figure A7-1.—Digital photography of edges and faces of panel A146-4 at 1741 ft/s with a BX-265 foam cylinder (nominally 1.25 in. in diameter by 3 in.) at a 90° impact angle. Test GRCC 25.

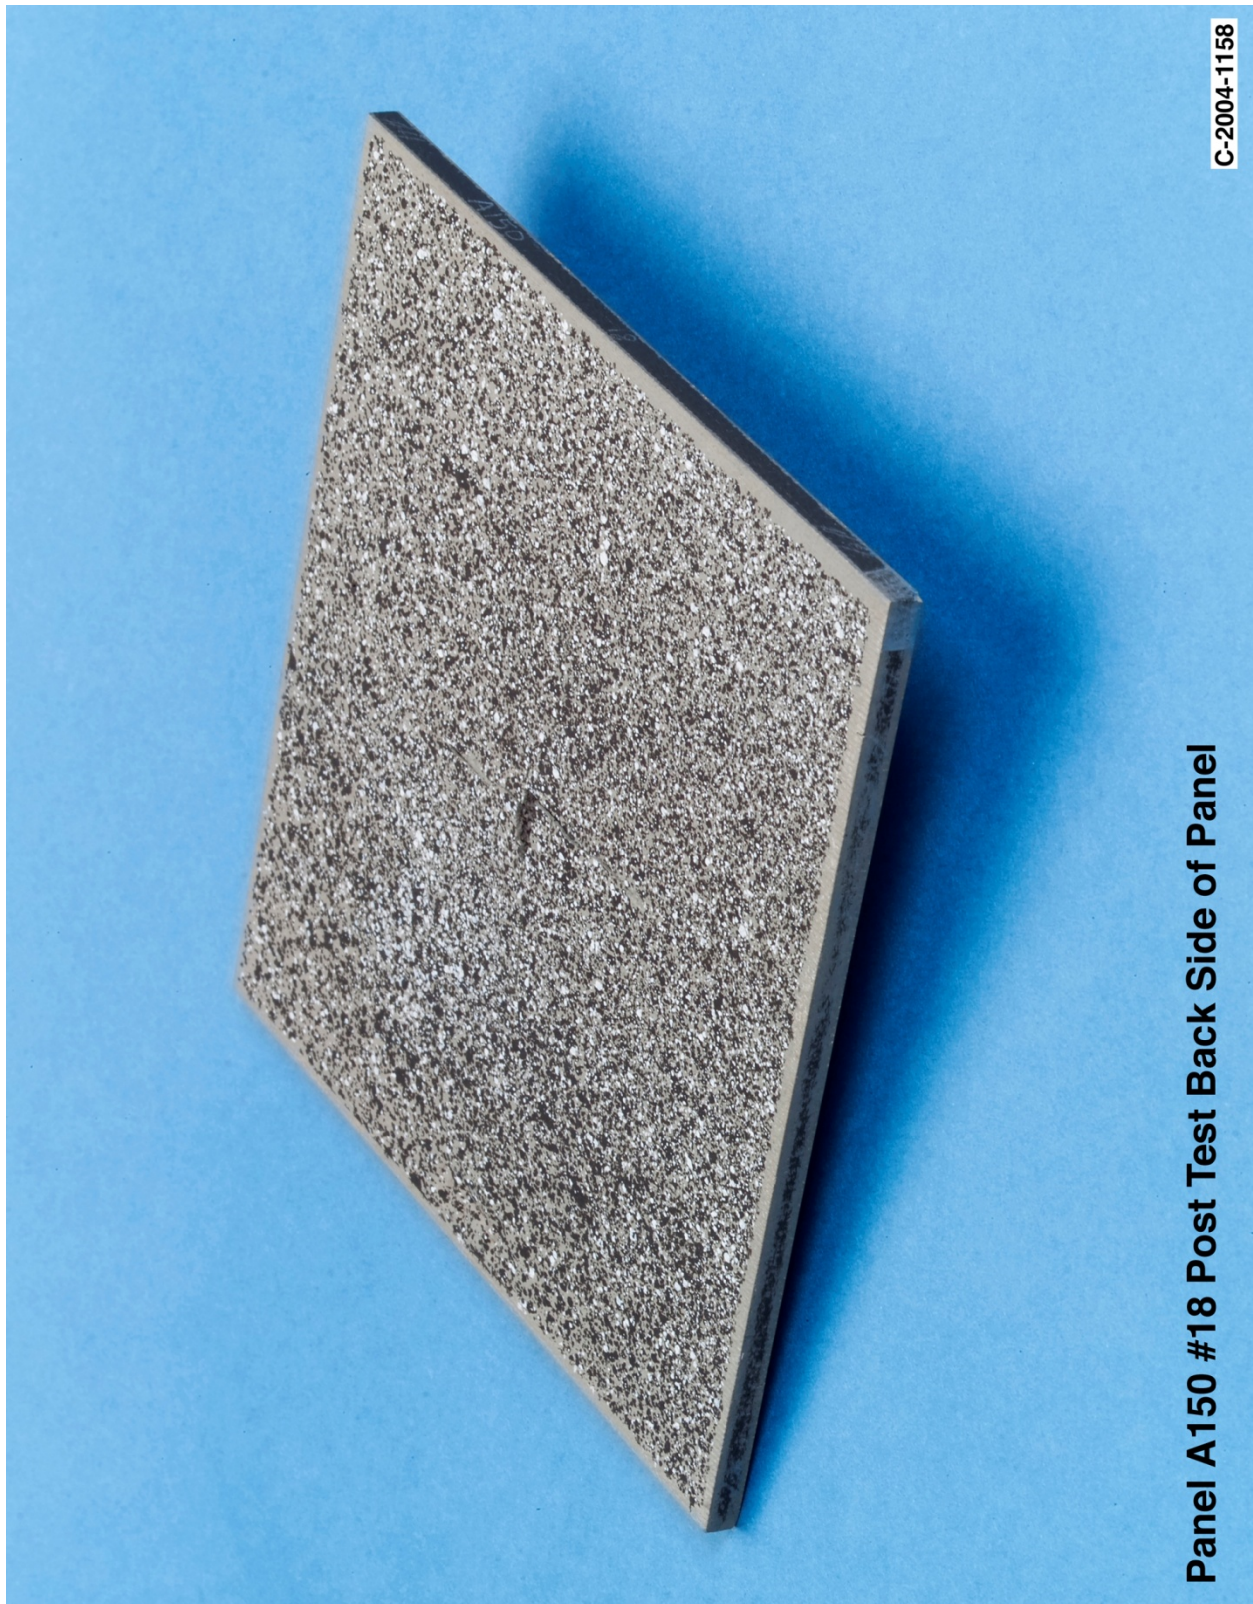
Figure A10-3.—Digital photography of back face of panel A150-18 at 1952 ft/s with a BX-265 foam (nominally 1.25 in. in diameter by 3 in.) at a 90° impact angle. Test GRCC 60.

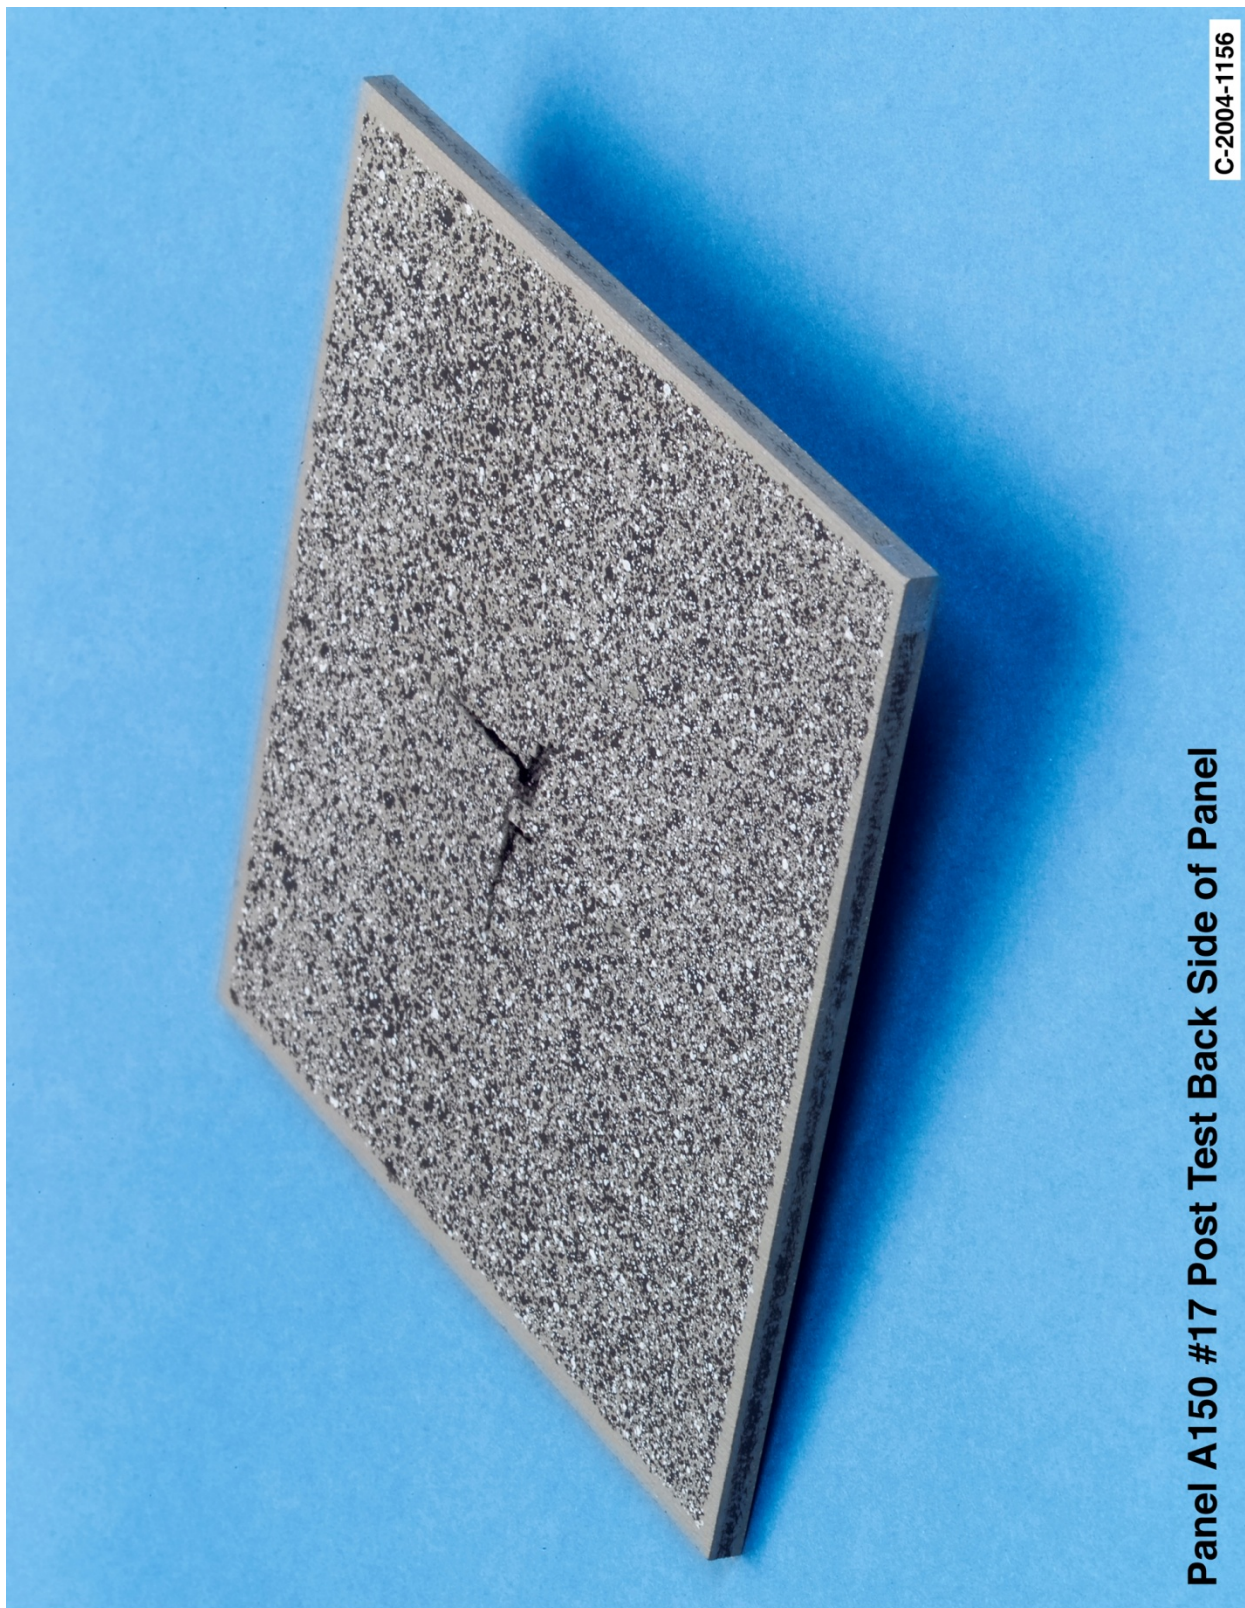
Figure A12-3.—Digital photography of back face of panel A150-17 at 2000 ft/s with a BX-265 foam cylinder (nominally 1.25 in. in diameter by 3 in.) at a 90° impact angle. Test GRCC 59.

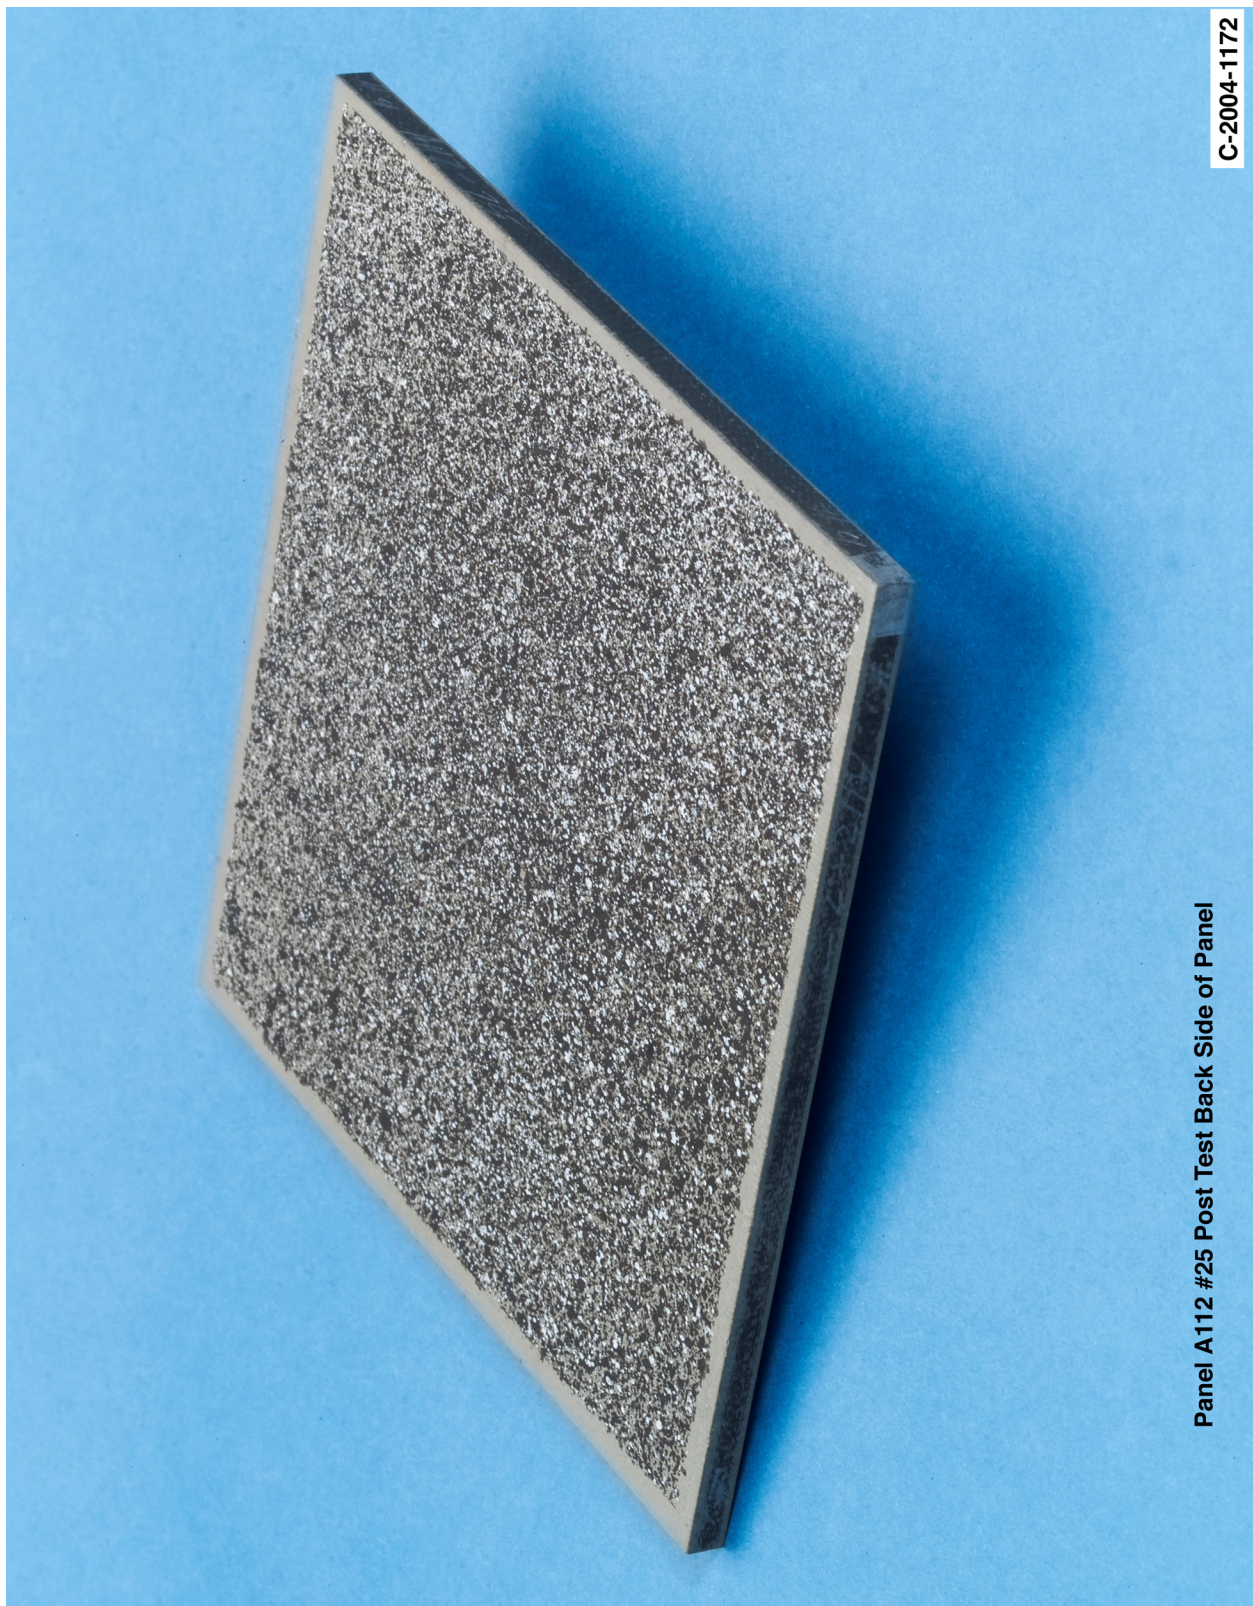
Figure B10-3.—Digital photography of back face of panel A112-25 at 1940 ft/s with a BX-265 foam cylinder (nominally 1.25 in. in diameter by 3 in.) at a 45° impact angle. Test GRCC 54.

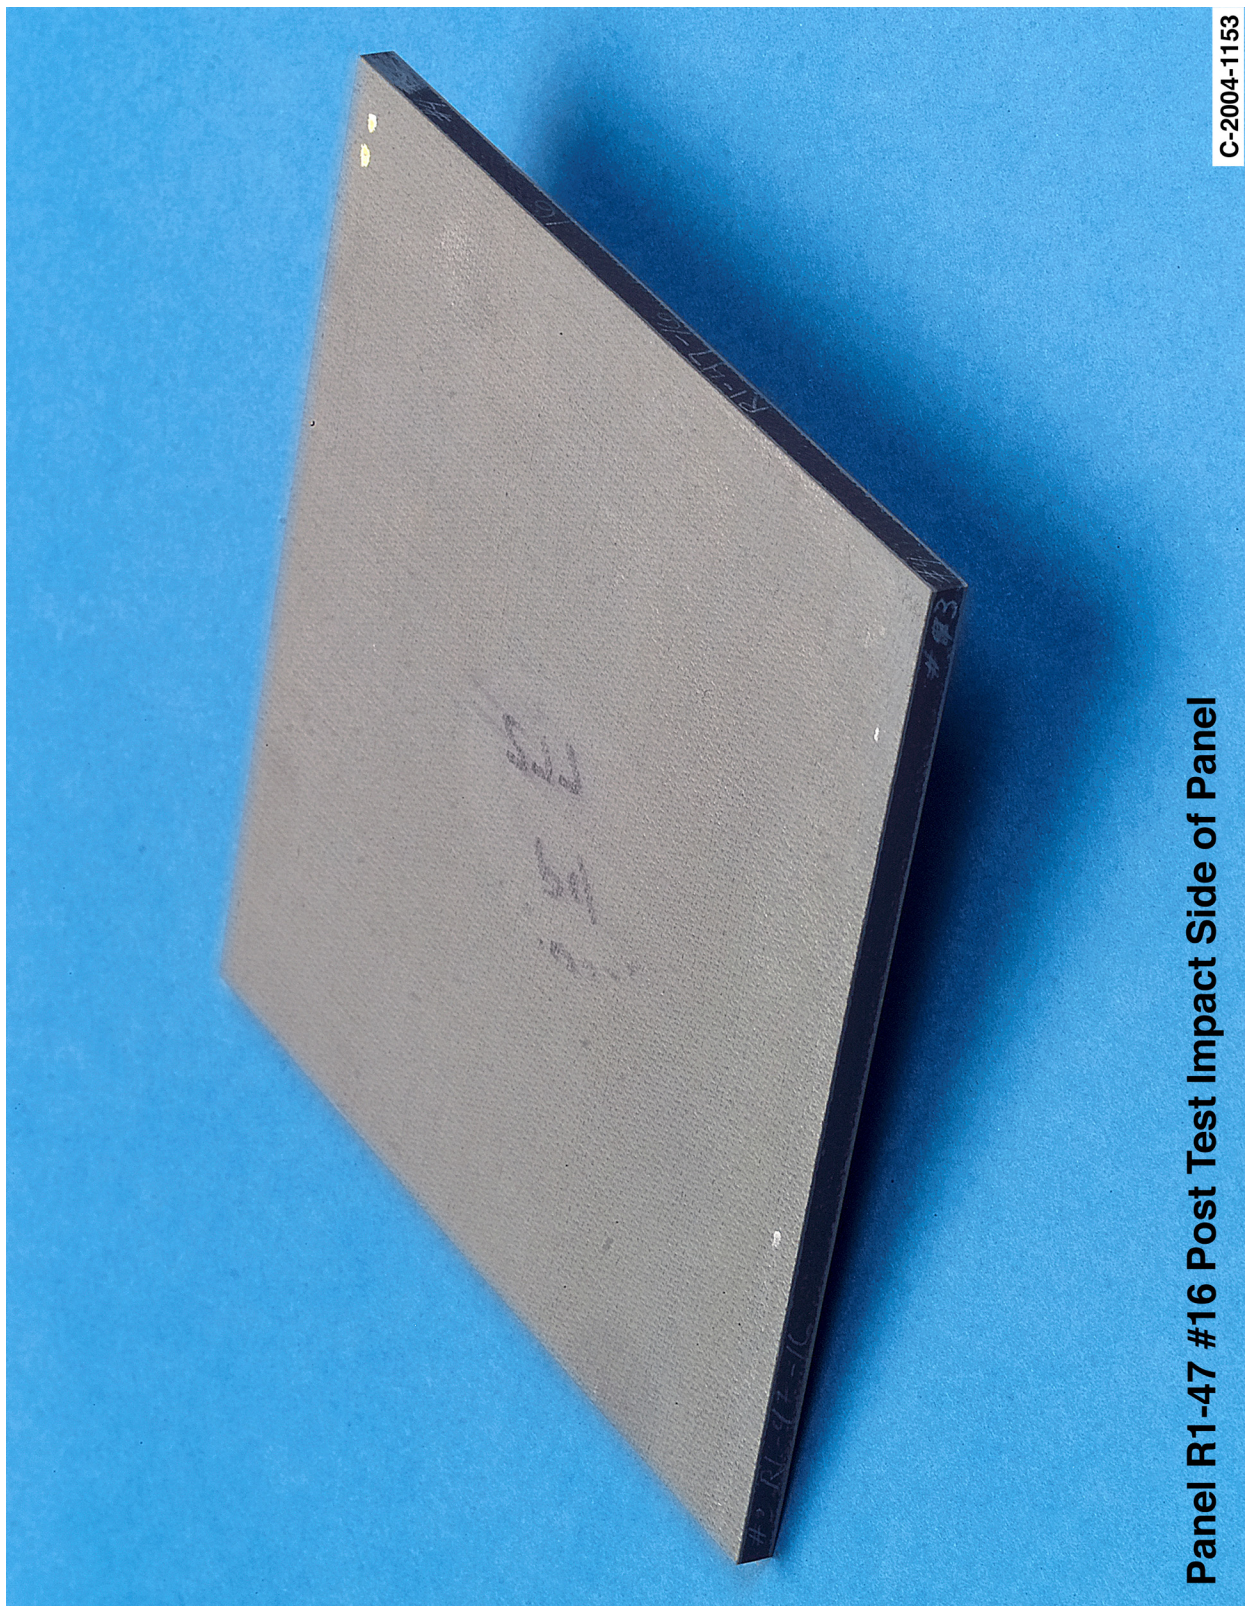
Figure B12-2.—Digital photography front (impact side) face of panel R147-16 at 1987 ft/s with a BX-265 foam cylinder (nominally 1.25 in. in diameter by 3 in.) at a 45° impact angle. Test GRCC 48.

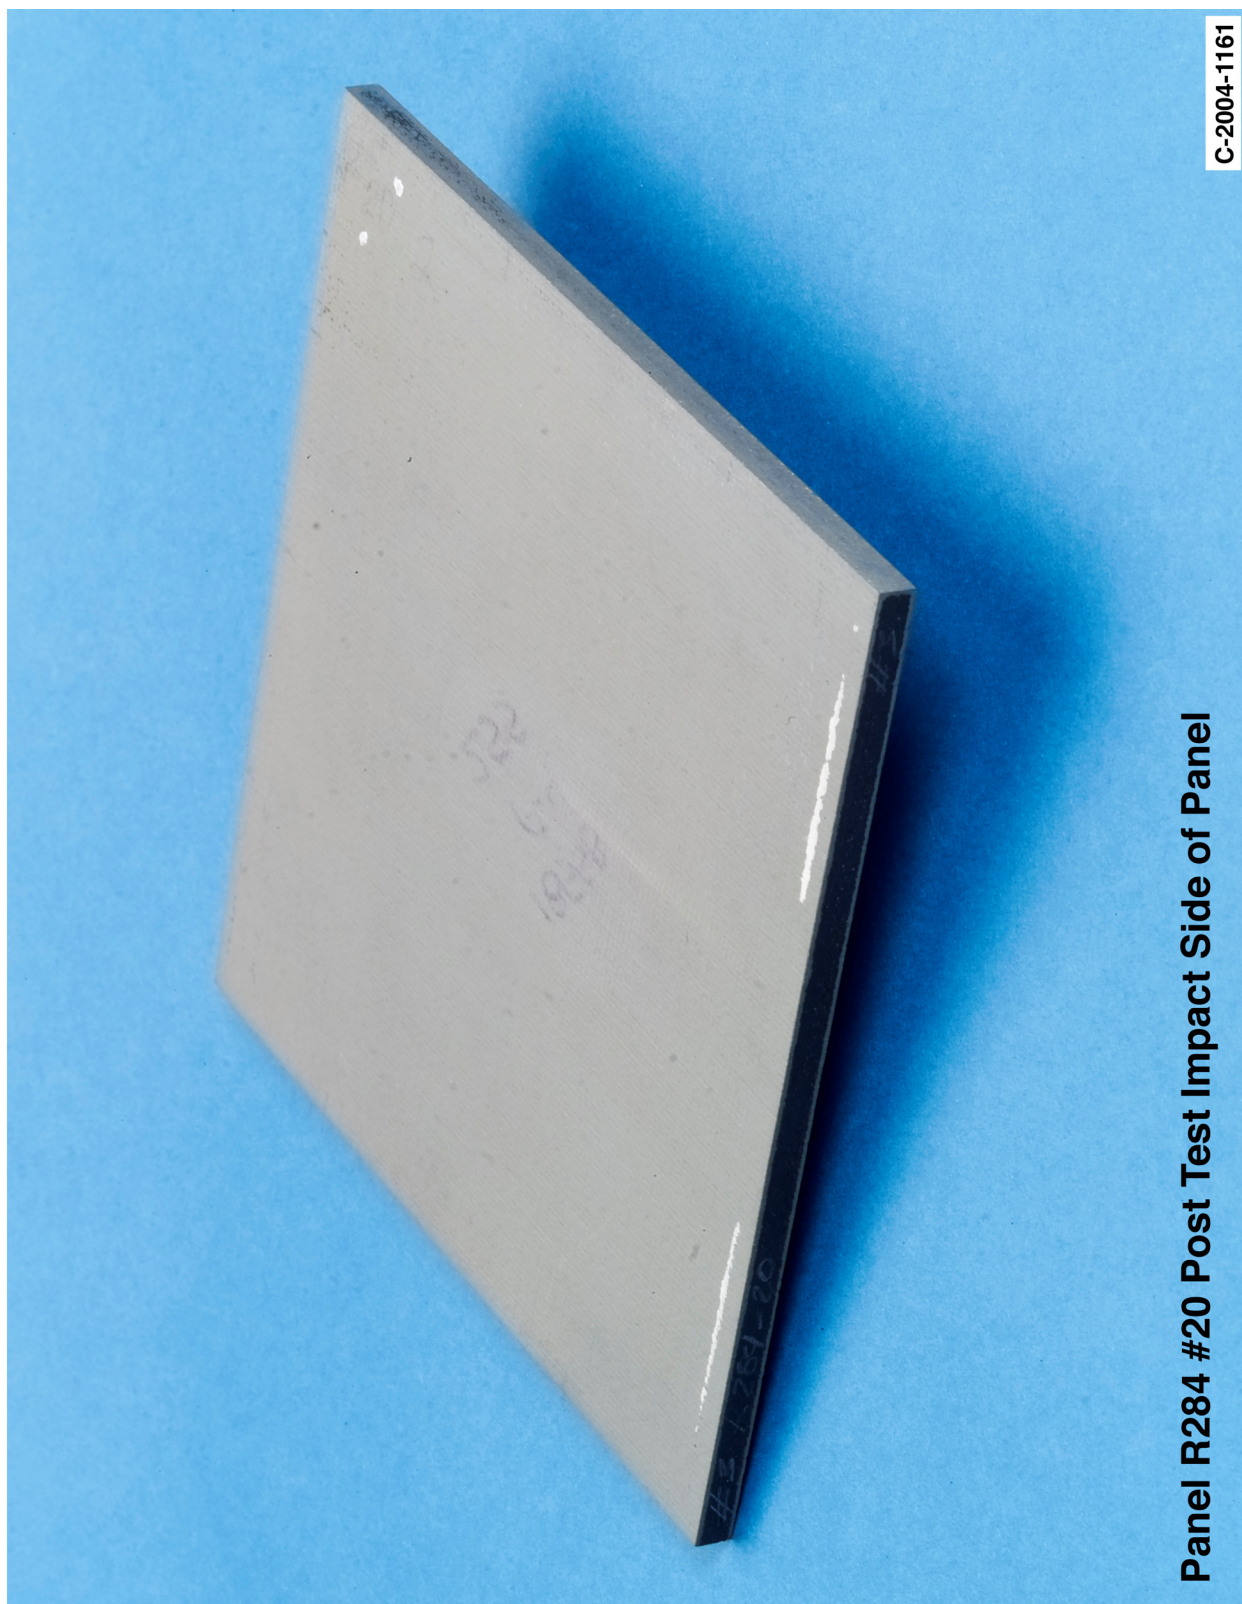
Figure B14-2.—Digital photography front (impact side) face of panel R284-20 at 2230 ft/s with a BX-265 foam cylinder (nominally 1.25 in. in diameter by 3 in.) at a 45° impact angle. Test GRCC 51.

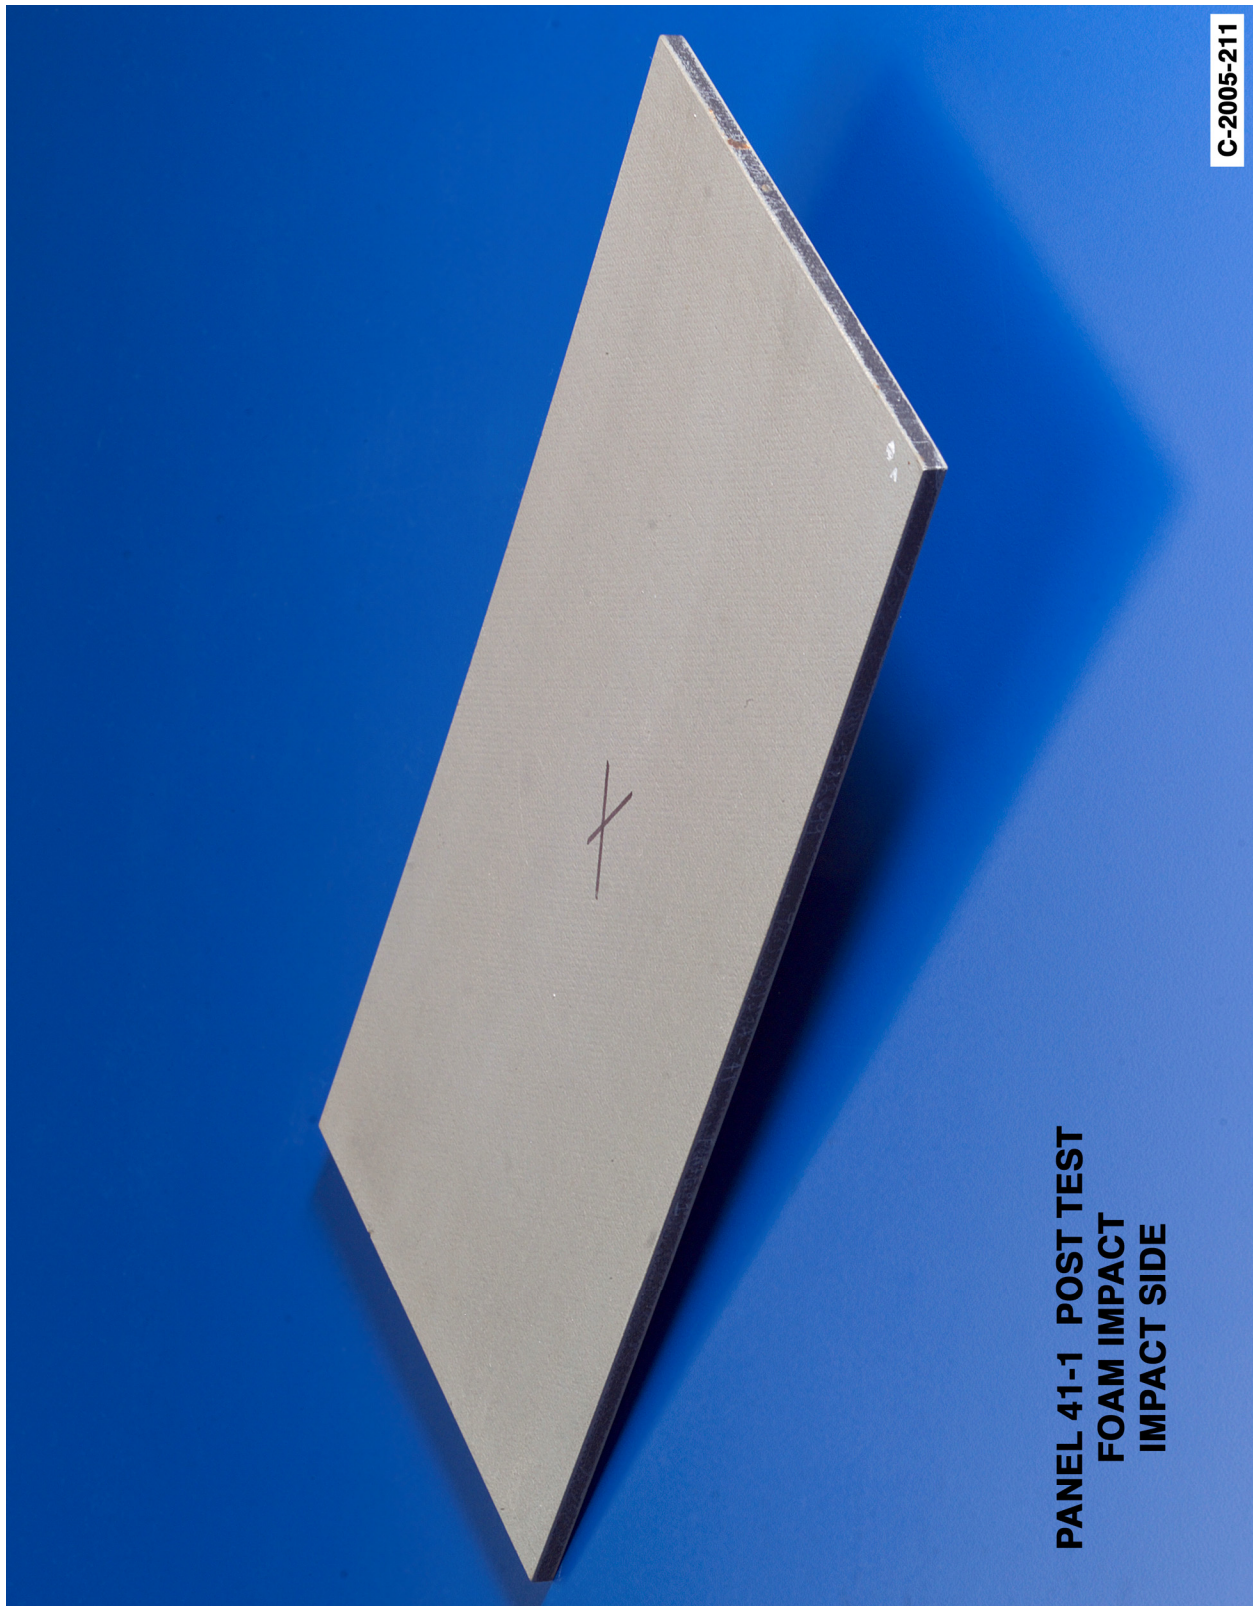
Figure C6-2.—Digital photography front (impact side) face of panel 41-1 at 1262 ft/s with a BX-265 foam cylinder (nominally 1.5 in. in diameter by 3 in.) at a 90° impact angle. Test GRCC 161.

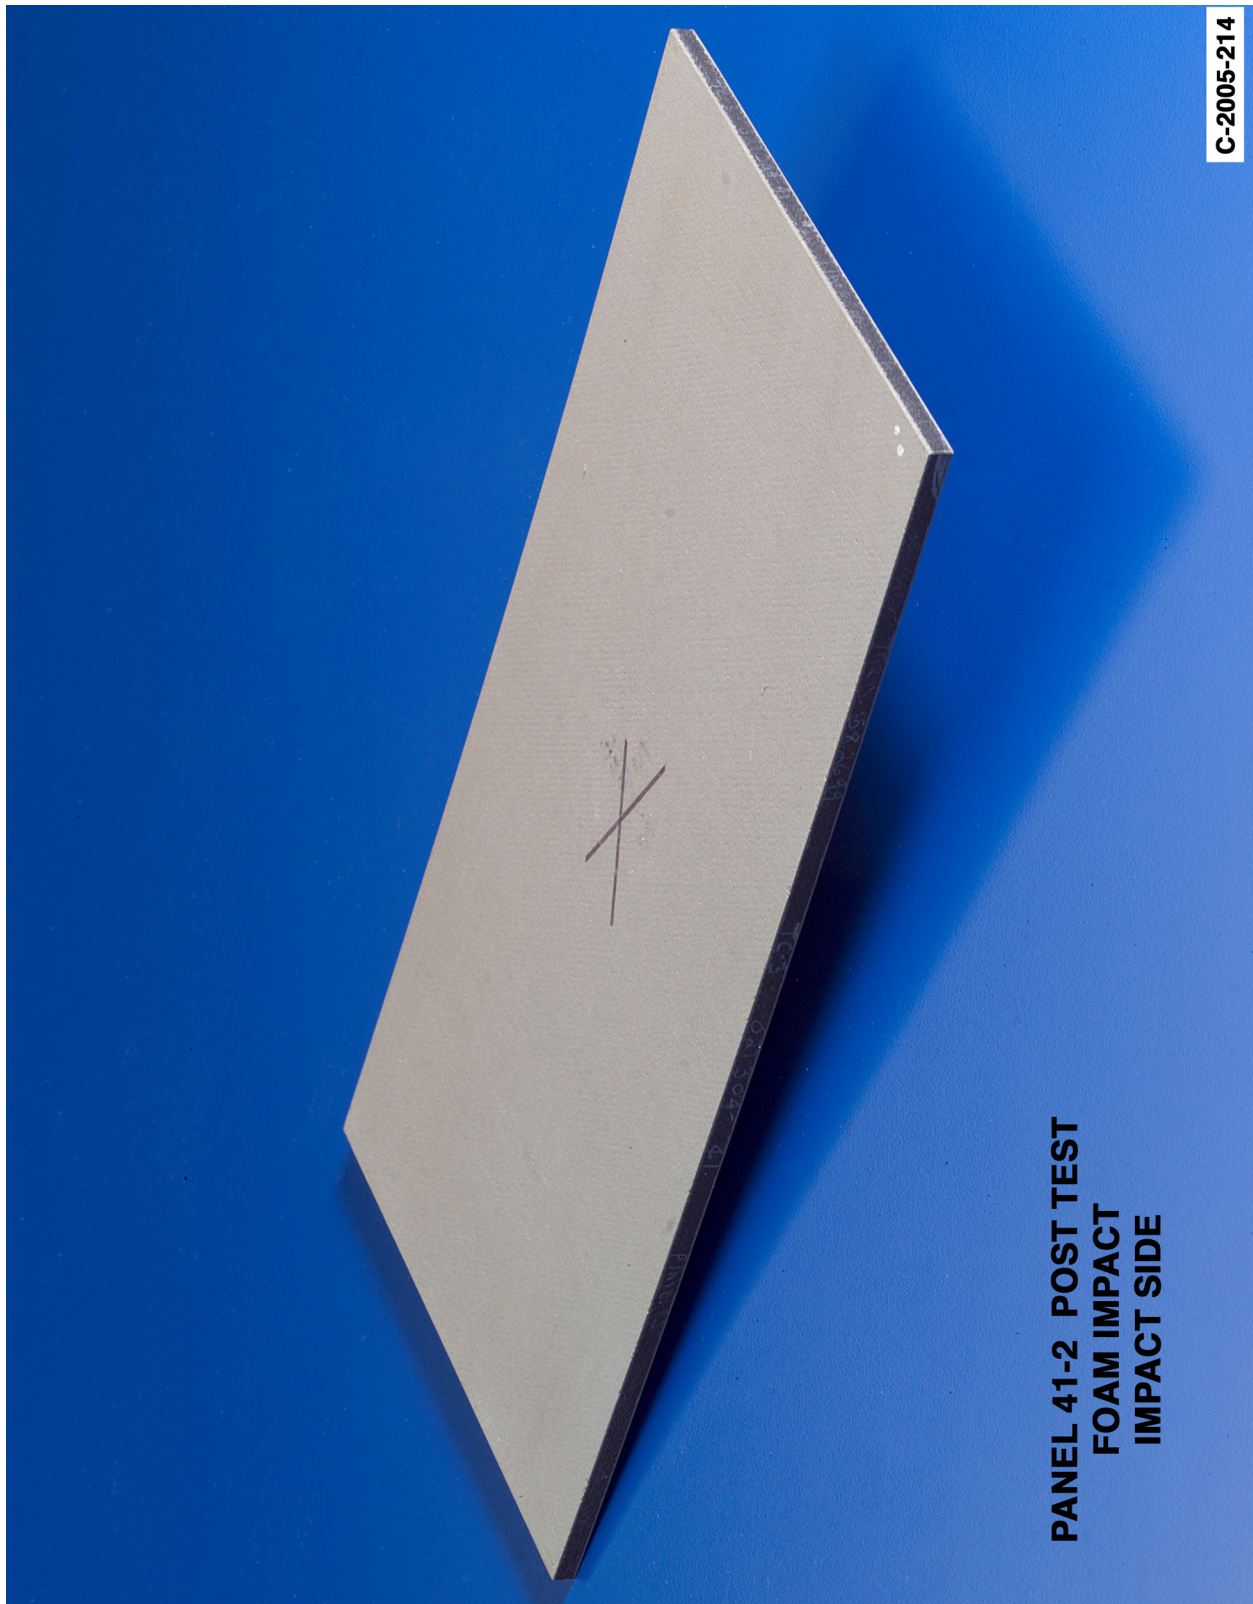
Figure C9-2.—Digital photography front (impact side) face of panel 41-2 at 1538 ft/s with a BX-265 foam cylinder (nominally 1.5 in. in diameter by 3 in.) at a 90° impact angle. Test GRCC 163.

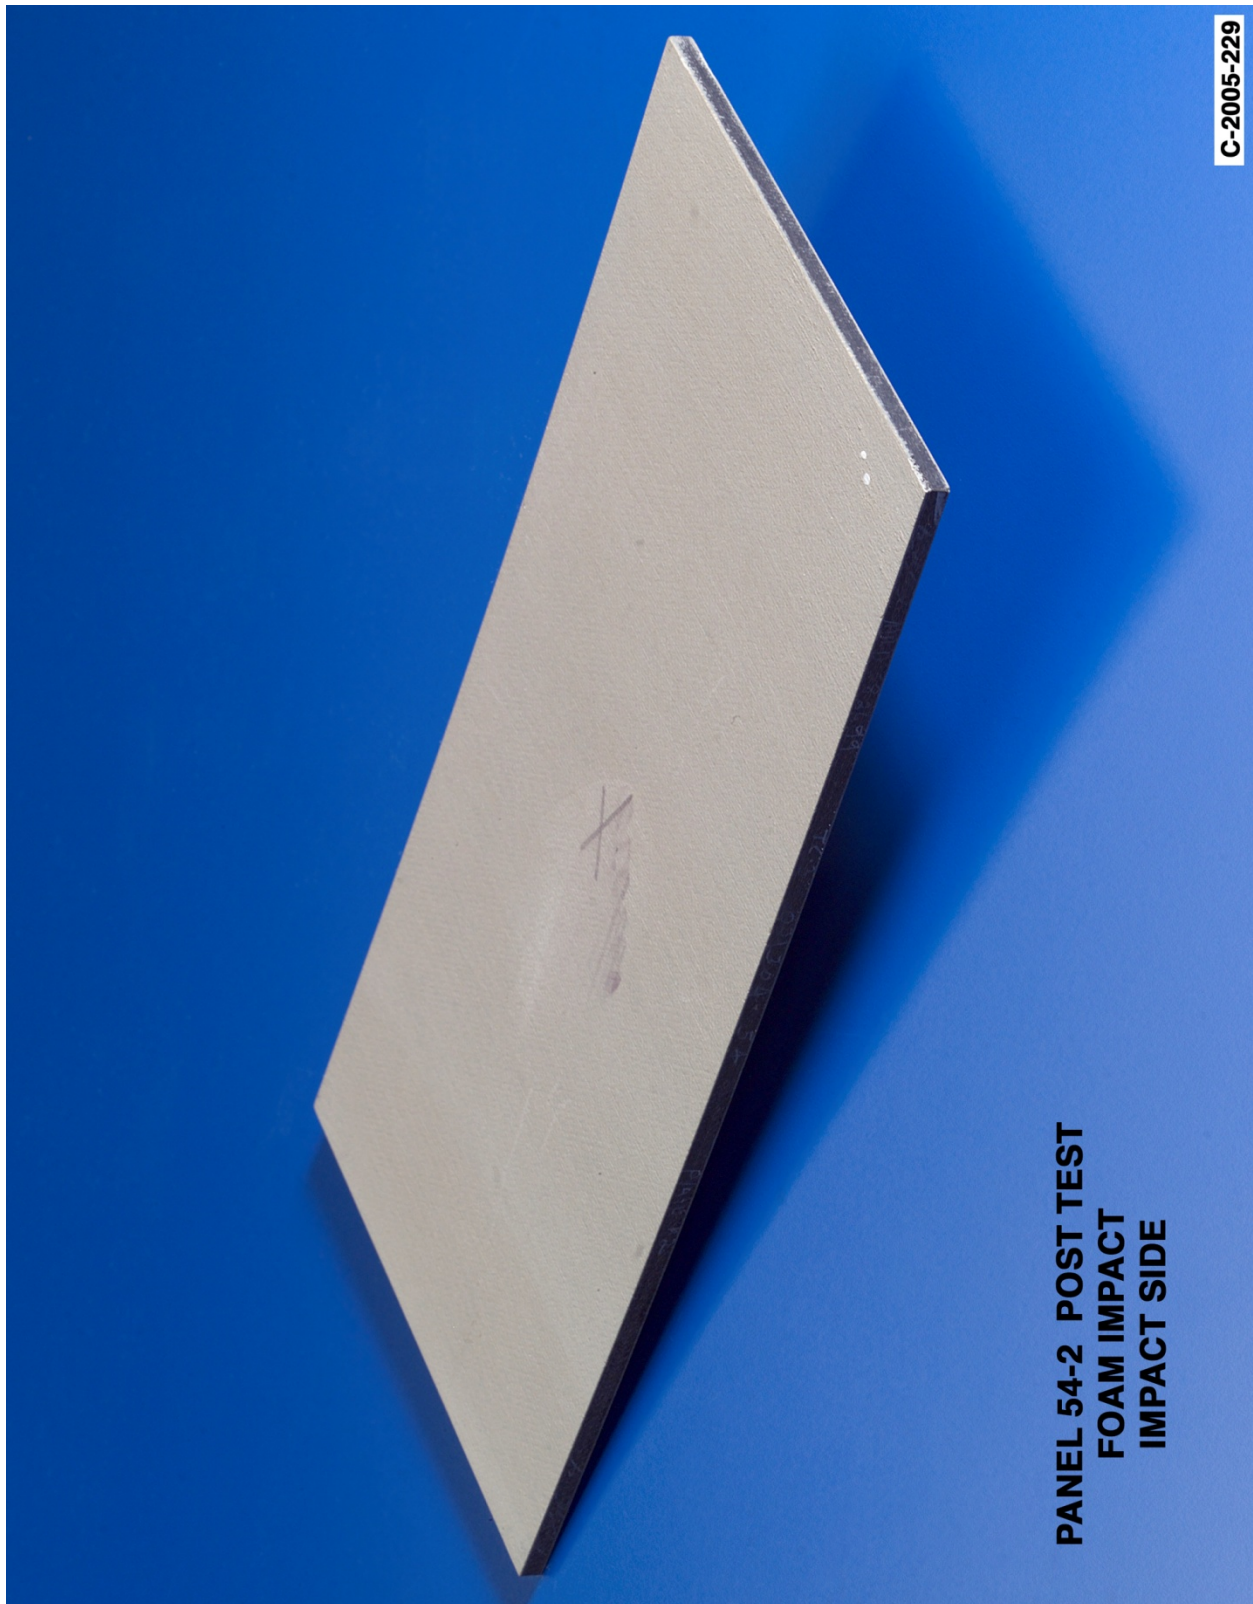
Figure D5-2.—Digital photography front (impact side) face of panel 54-2 at 1381 ft/s with a BX-265 foam cylinder (nominally 1.5 in. in diameter by 3 in.) at a 45° impact angle. Test GRCC 172.

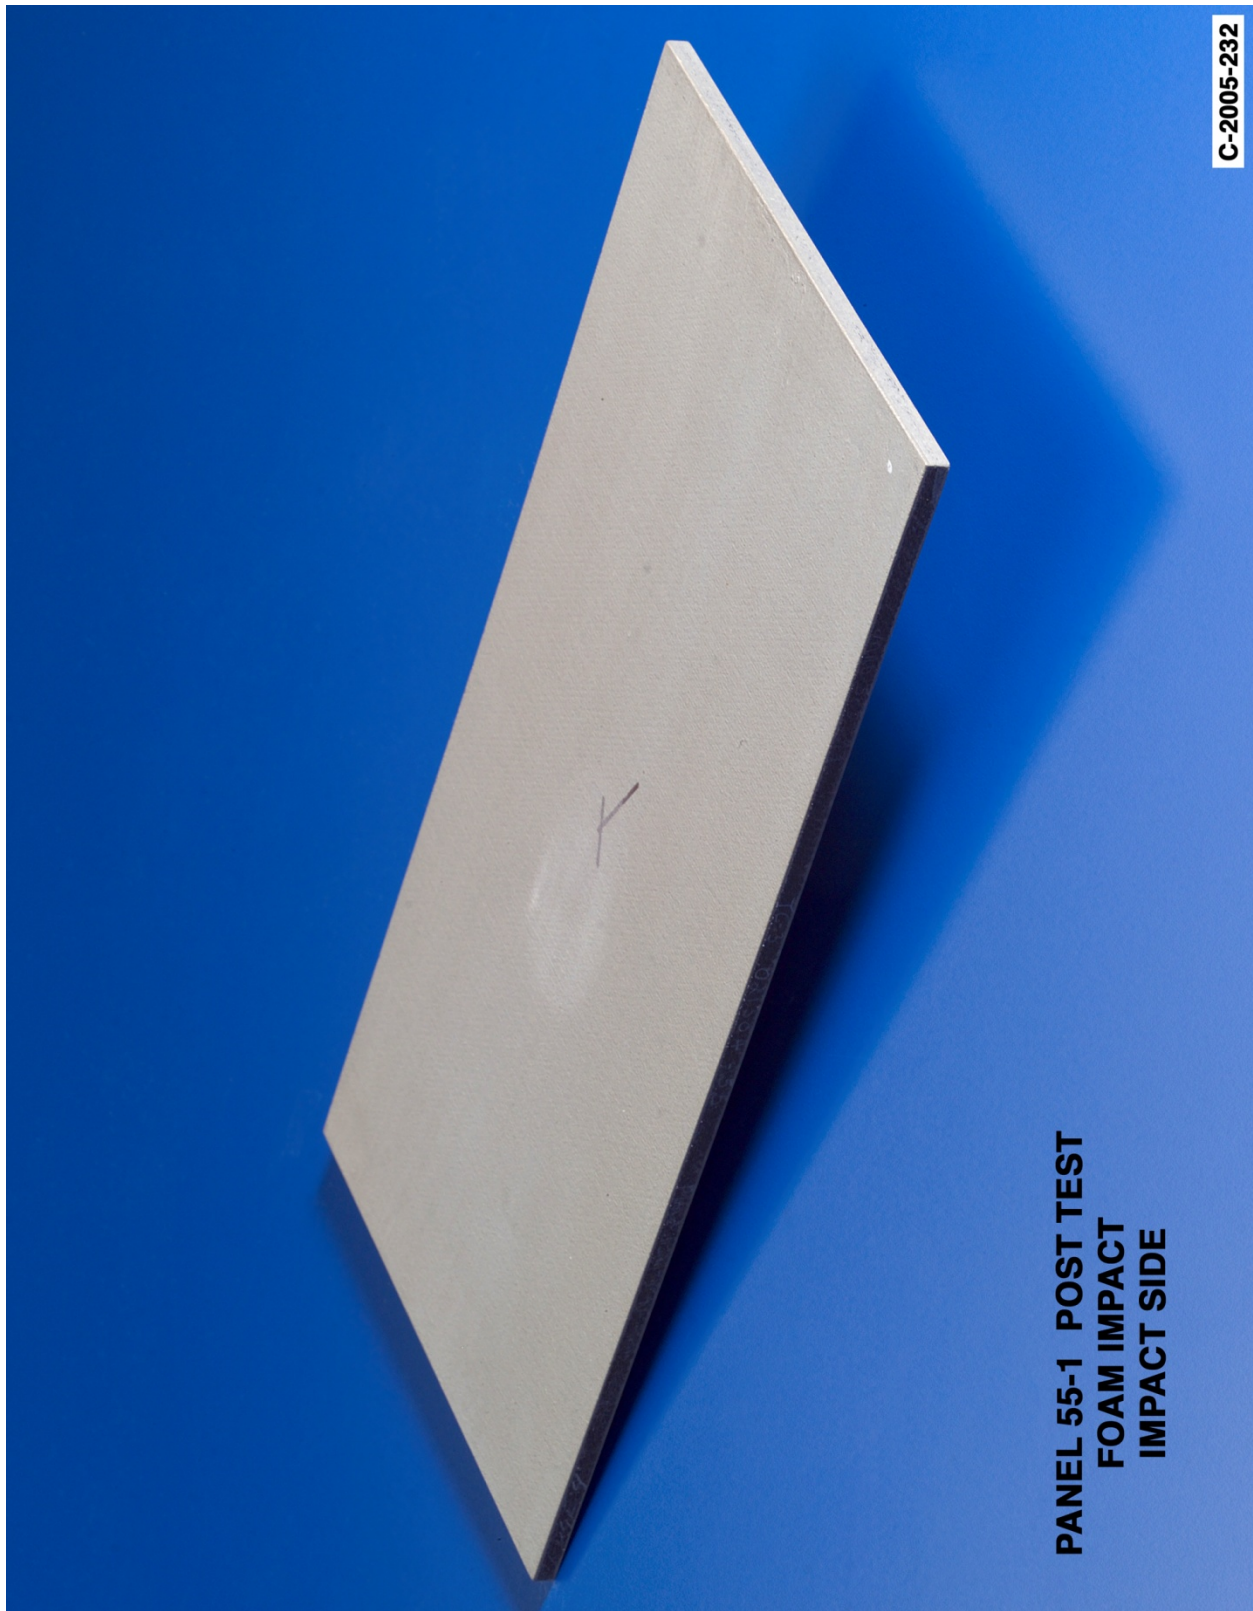
Figure D6-2.—Digital photography front (impact side) face of panel 55-1 at 1795 ft/s with a BX-265 foam cylinder (nominally 1.5 in. in diameter by 3 in.) at a 45° impact angle. Test GRCC 174.

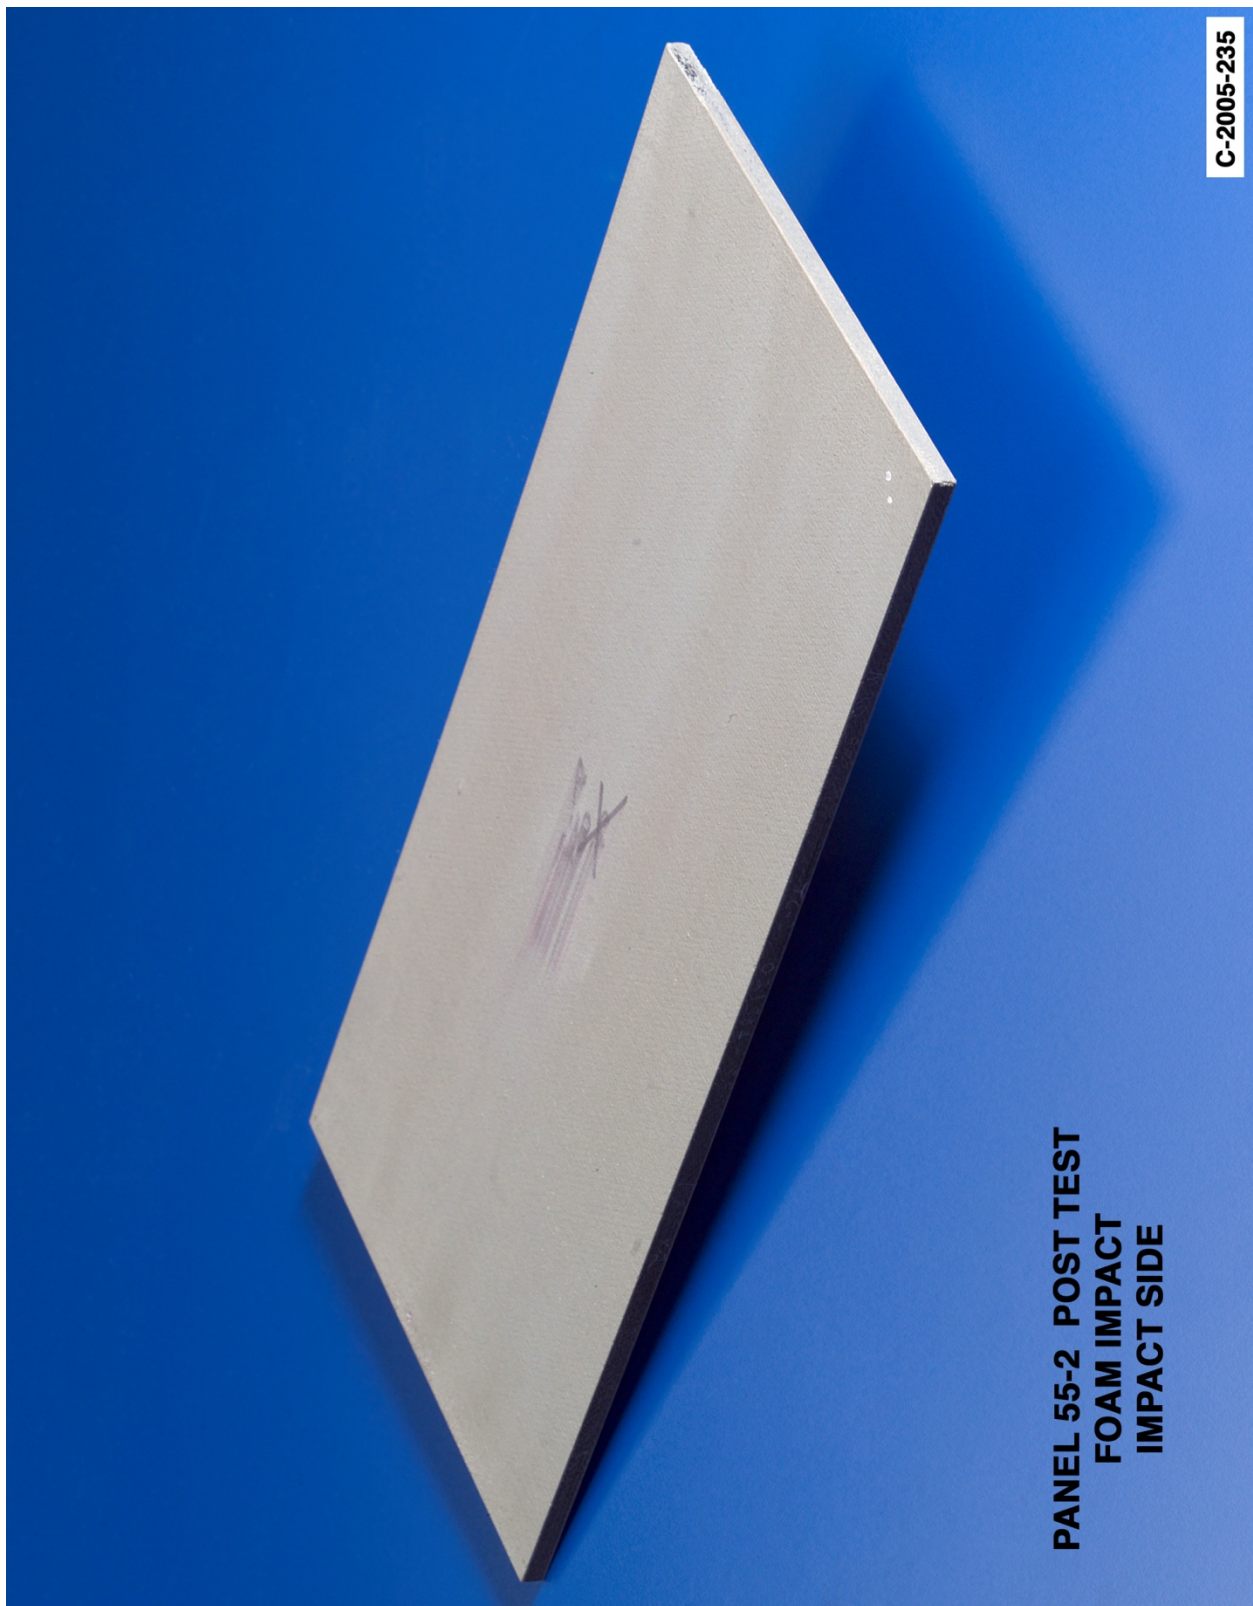
**PANEL 55-2 POST TEST
FOAM IMPACT
IMPACT SIDE**

Figure D7-2.—Digital photography front (impact side) face of panel 55-2 at 1853 ft/s with a BX-265 foam cylinder (nominally 1.5 in. in diameter by 3 in.) at a 45° impact angle. Test GRCC 176.
